Manhole Inspection Summary

Manhole # S15CC2005MH

Insp Date: **7/20/06 10:19 AM**

Location Address: **2004 SOUTH RD** Cross Street: **WILDWOOD LN**

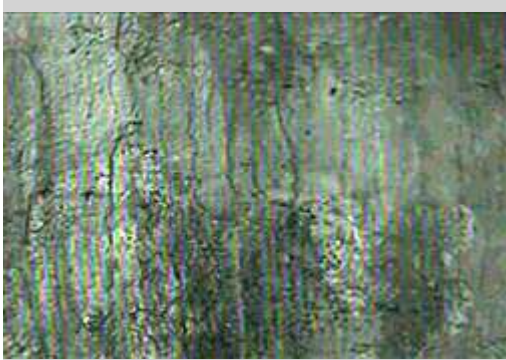
Defect

Barrel Material: **Concrete** ☒ Parged
Shape: **Rectangular** Diameter: **55** (in.) Length: **38** (in.)
Condition: ☒ Sound ☐ Cracked ☐ Root Intrusion ☐ Loose Brick ☐ Deteriorated
Infiltration: ☐ None ☒ **Joint** ☐ Cracks ☐ Mortar ☐ Roots ☒ **Wall**

Barrel infiltration.

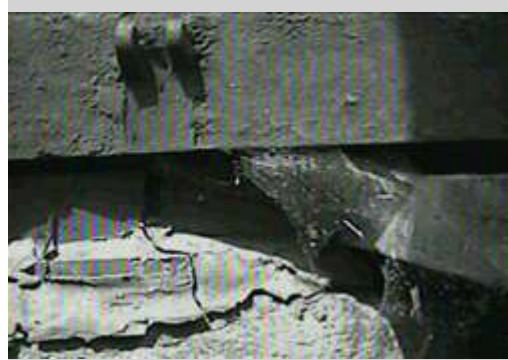
Defect

Frame Offset: **0** (in.) Condition: ☐ Sound ☐ Cracked ☒ **Leaks**

Frame leaks. Corbel infiltration. Cracked parging.

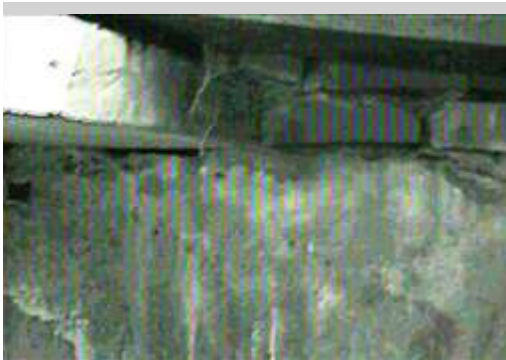
Defect

Corbel Material: **Brick and Concrete** ☒ Parged Type: **Flat top**
Condition: ☐ Sound ☐ Cracked ☐ Root Intrusion ☐ Loose Brick ☒ **Deteriorated**
Infiltration: ☐ None ☒ **Joint** ☐ Cracks ☒ **Mortar** ☐ Roots ☐ Wall

Corbel deterioration and infiltration.

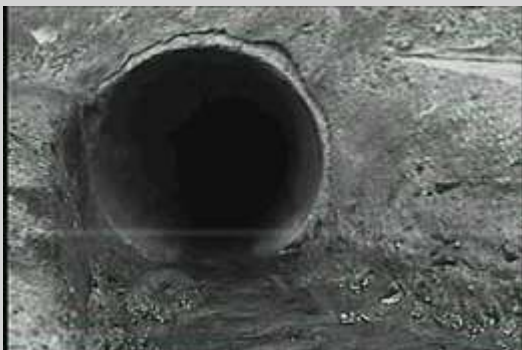
8 in. Circular Gravity Sewer

Comments **The I9 pipe seal is not flush to the pipe.**

Deposits: ☐ None ☐ Mud ☒ ~~Sludge~~ ☒ **Debris** ☐ Grease

Silt Depth: **0** (in.) Deposits Extent: **Light**

Infiltration: **Evidence**
